PREPURCHASE INSPECTION REPORT

2024 CHEVROLET Corvette Preferred 2LT

Specialty package | Report date: Aug 12, 2026

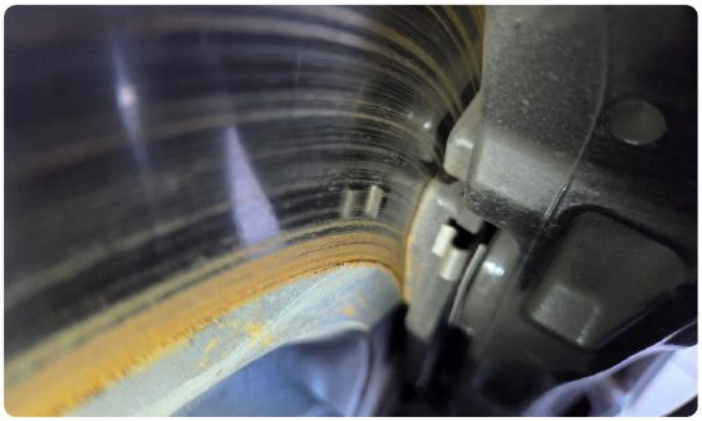
-Due to the car sitting, rotors developed deep surface rust that causes vibration/pulsation. Car needs to have brakes serviced. - Chip in paint in the front

Mechanical: Brakes
Front Rotors surface rust

Road test: Braking
Brake pedal feel was great however had brake pulsation due to front rotors most likely.
