PREPURCHASE INSPECTION REPORT

2015 HONDA CR-V EX-L

Specialty package | Report date: Aug 15, 2026

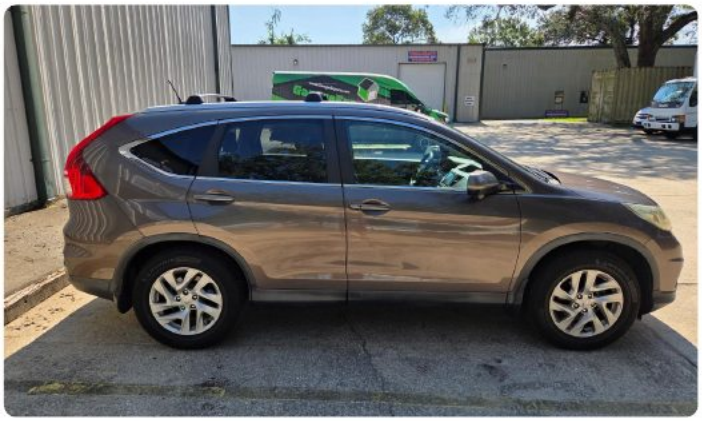
Rear wiper bad

Bumper scratches

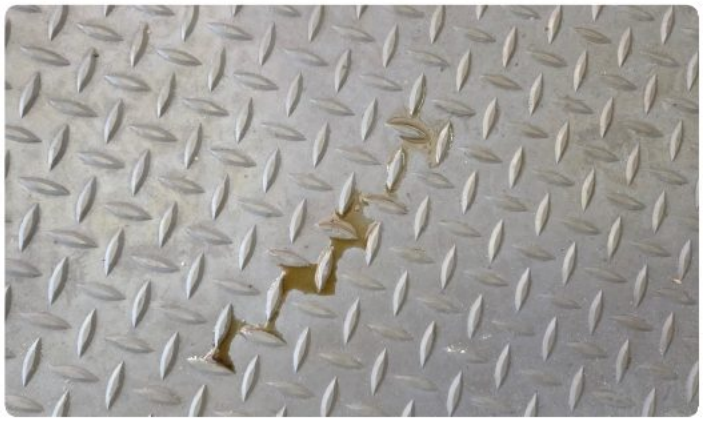
Oil leak overnight

Oil plug leak

Mechanical: Engine bay
Oil leak from drain plug being very loose. Some evidence of additional minor leak however might have been from plug. PLUG TIGHTENED

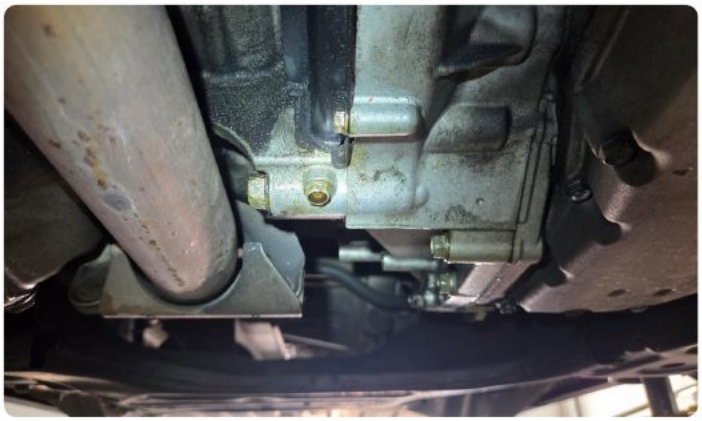
Mechanical: Suspension / steering
Lower front ball joints L/R need replacement

Oil seepage

Ball joint right

Ball joint left

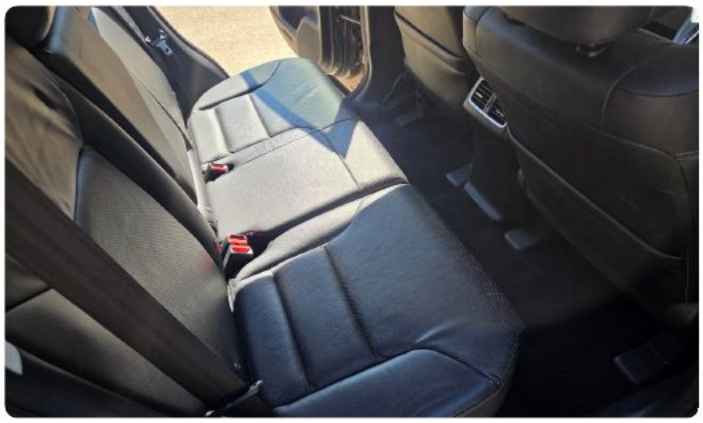
Interior: Seat and trim wear
Seat wear, steering wheel wear

Steering wheel wear
